**US Army Corps
of Engineers**

CERL Technical Report 99/66
August 1999

Technical Assistance To Supplement Installation of Low NO_x Boilers at the Pentagon Heating and Refrigeration Plant

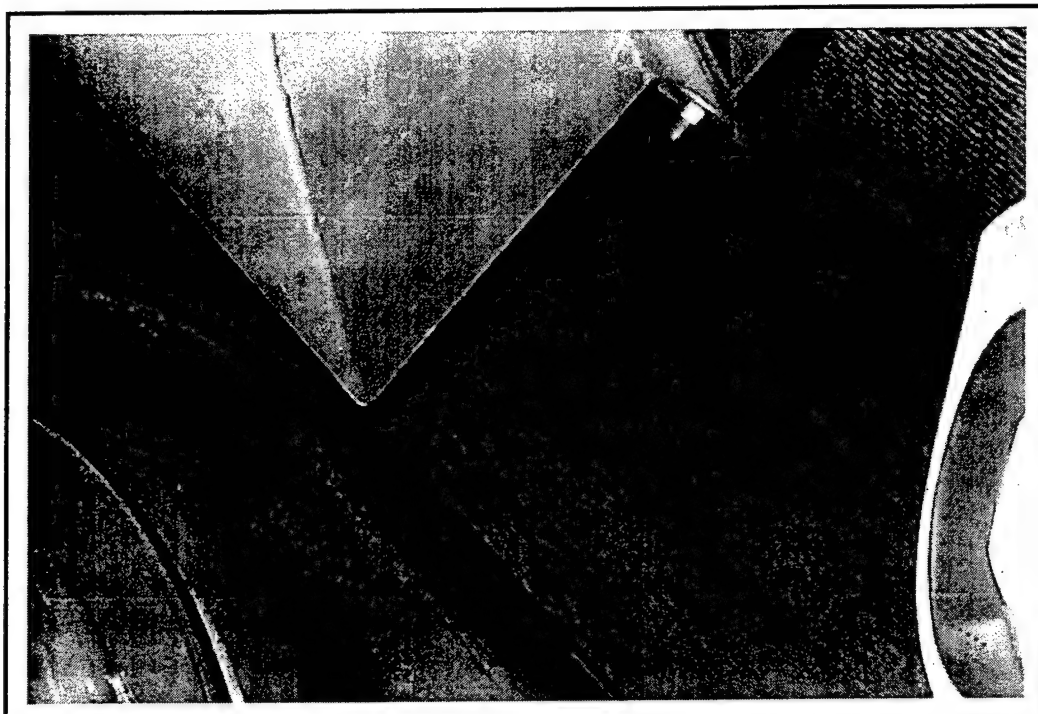
The installer opened up the windbox and furnace on Boiler #5. The windbox and burner are simple in construction. There are no vanes or baffles to ensure thorough mixing of the flue gas prior to entry to the burner throat. Corrosion had already begun to occur where the flue gas entered the windbox (Figure 2). The burner has one set of flat register vanes (Figure 3). The tubes in the windbox did not show any signs of flame impingement although boiler #5 did not have many hours of operation. The laydown chalk makings were still visible. The soot pattern from burning oil can be seen on the left furnace wall (Figure 4).

Figure 2. Windbox corrosion.

- Corrosion is already present in the windbox where the flue gas enters. The corrosion will shorten the life of the windbox equipment. Condensation of moisture in the windbox is not observed with induced flue gas recirculation burners. Although the boilers were specified to be able to burn #6 oil, such

sulfur-bearing fuels cannot be burned unless the burner and windbox is fabricated out of 316L stainless steel.

- If the capability to burn #6 fuel oil must be maintained, install a new FD flue gas burner and or fan. The components in contact with the flue gas need to be fabricated out of 316L stainless steel. This is the most expensive option and only has merit if the #6 oil option must be maintained.

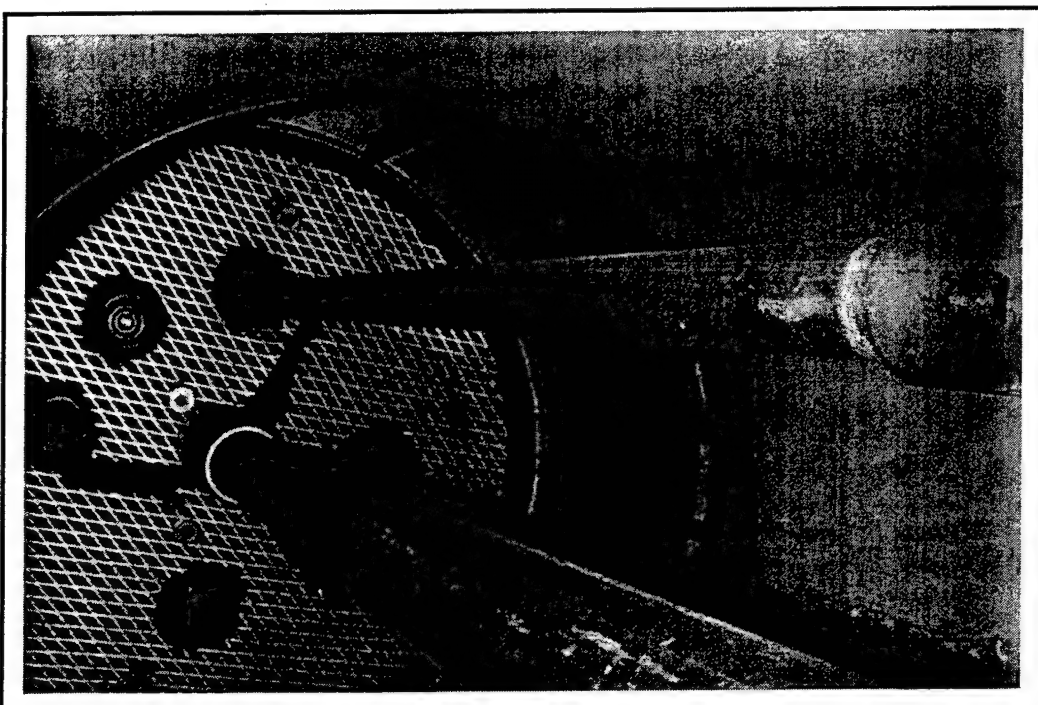
Figure 3. Burner register.

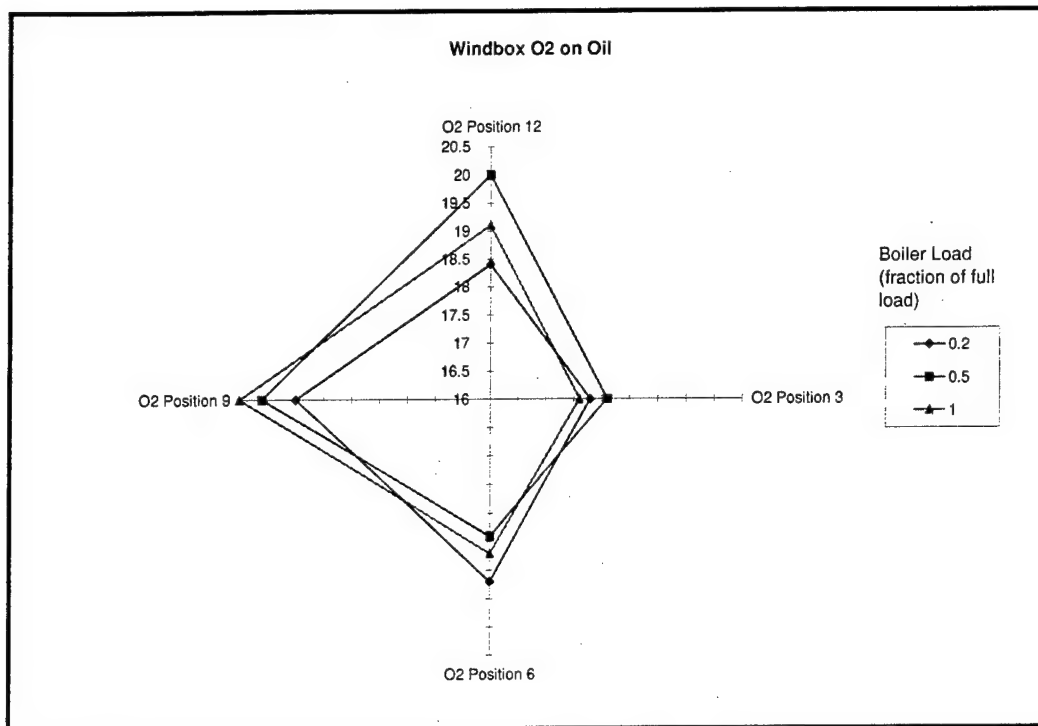
The team sampled the combustion air and flue gas mixture at four positions around the entrance to the burner register. They removed one bolt at a time from the front of the burner to insert a K type thermocouple and gas analyzer probe (Figure 5). The sampling was done at low fire, 50 percent steam load, and 100 percent steam load on oil and gas. Sample results indicated that the flue gas and combustion air were not thoroughly mixed entering the burner (Figures 6 and 7). The gas flame was observed to have colder and hotter quadrants. At 50 percent load, the top half was much hotter as indicated by the glowing refractory. At 100 percent load, the hot quadrant rotated clockwise (as viewed from the rear of the boiler) about 90 to 140 degrees. Thermocouple data confirmed that the oxygen-rich quadrants are near the top at 50 percent load and shift at least one quadrant during 100 percent load (Figure 8). The gas flame is affected by the unmixed air supply stream at all loads. The lower portions of the flame front are pulled down and out of shape.

Figure 6. Windbox oxygen concentration at three loads.

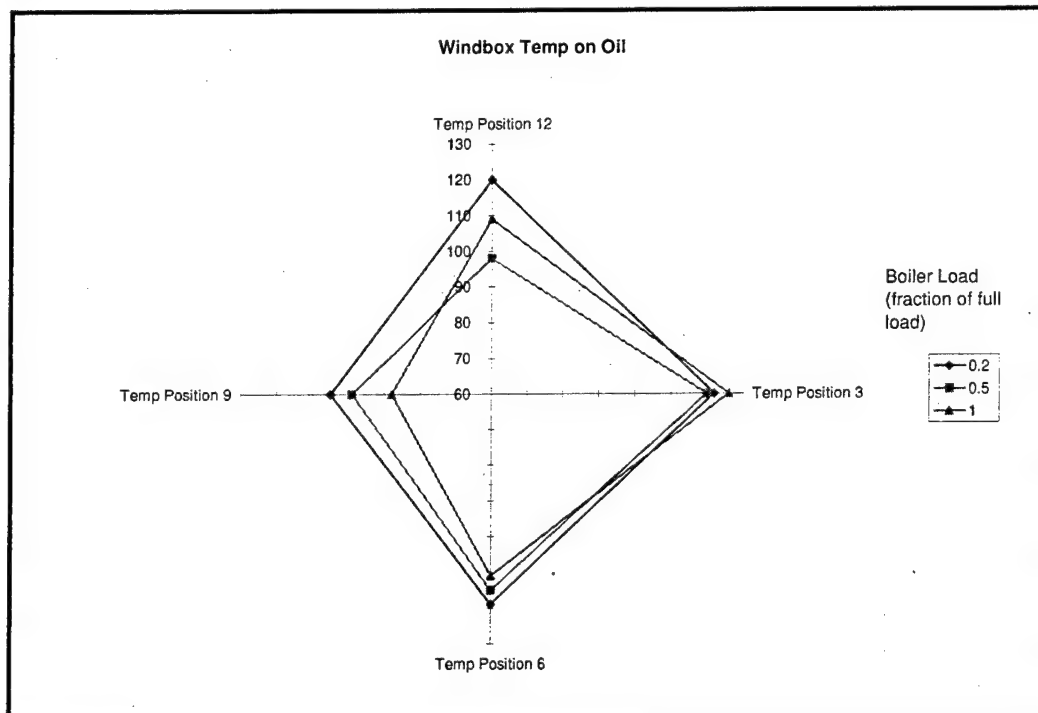
Figure 7. Windbox temperature at three loads.

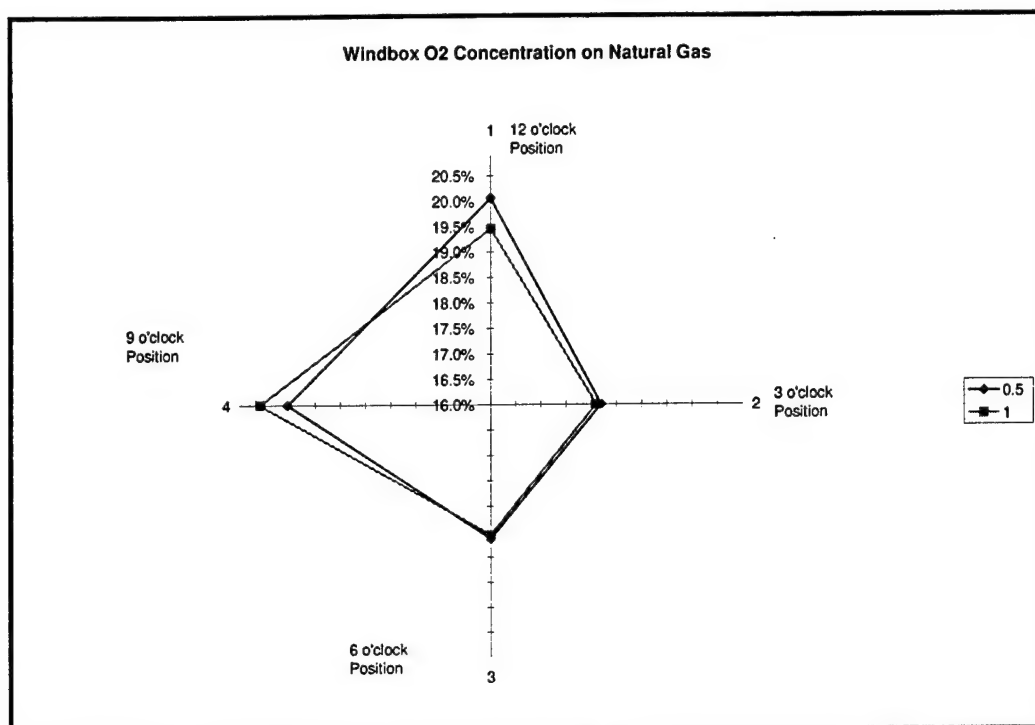
Figure 8. Windbox oxygen concentration on natural gas.

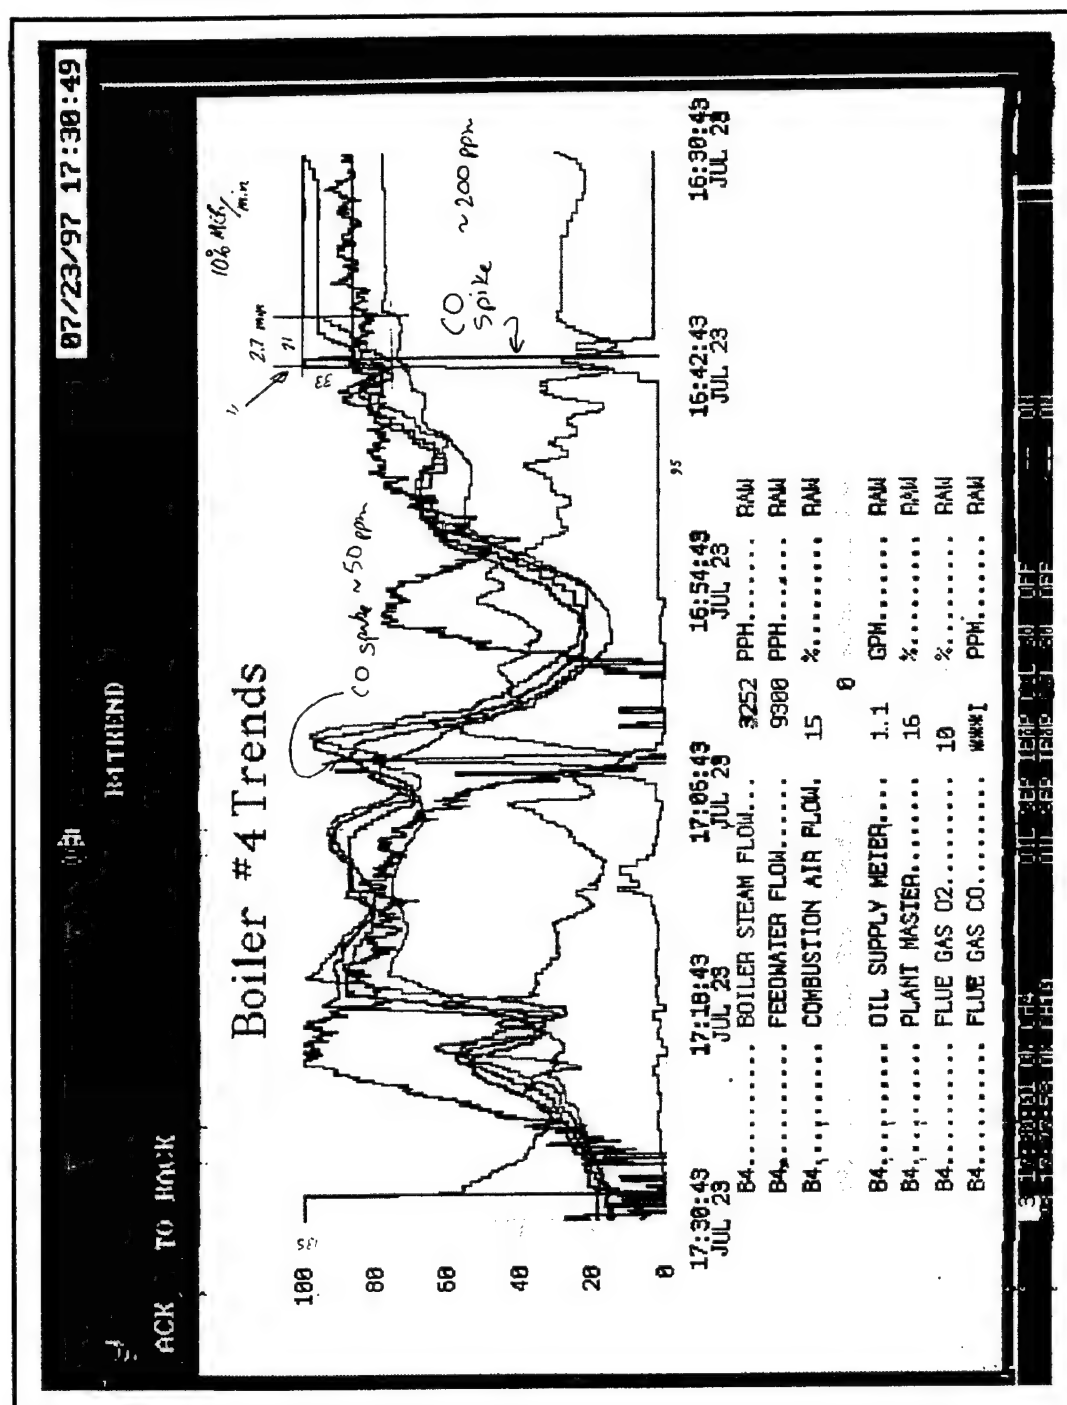
The PRO letter also states that "unexpected carbon monoxide excursions were witnessed 7-9 May 1997 which were possibly due to DCS communications failure." When operating above the turndown limit of 6 to 1, the burners performed satisfactorily. On 23 July 1997, when changing the steam load manually at very high rates (greater than 10 percent Max Continuous Rating [MCR] per minute), there were two CO excursions above 50 PPM when near full load followed by dropping load quickly. (Figure 9 shows the DCS printout.) It was not clear to the team why the excursions occurred under these abnormal operating conditions. Although the load change was abnormal, a parallel metered control system should have been able to handle that change. The control system did respond to the excursion appropriately and increased air to quickly reduce the CO levels. The fuel train may need closer examination to precisely identify the cause of the CO excursion. The control system characteristic curve may need adjustment. For an unknown reason at 16:40 on 23 July, the controls let the fuel valve remain fully open for 30 to 60 seconds after the airflow was being reduced. It appears that the control system ruled that the airflow was so excessive that the fuel did not need to be reduced until the airflow signal had dropped significantly. One factor may be that the fuel oil supply pressure was increased slightly to try to reach full load. The burner did perform safely under normal load transients. However, if the current airflow-metering scheme is used, the team has recommended that the control system characteristic curve be inspected and recalculated.

Figure 9. DCS printout showing boiler No. 4 trends.

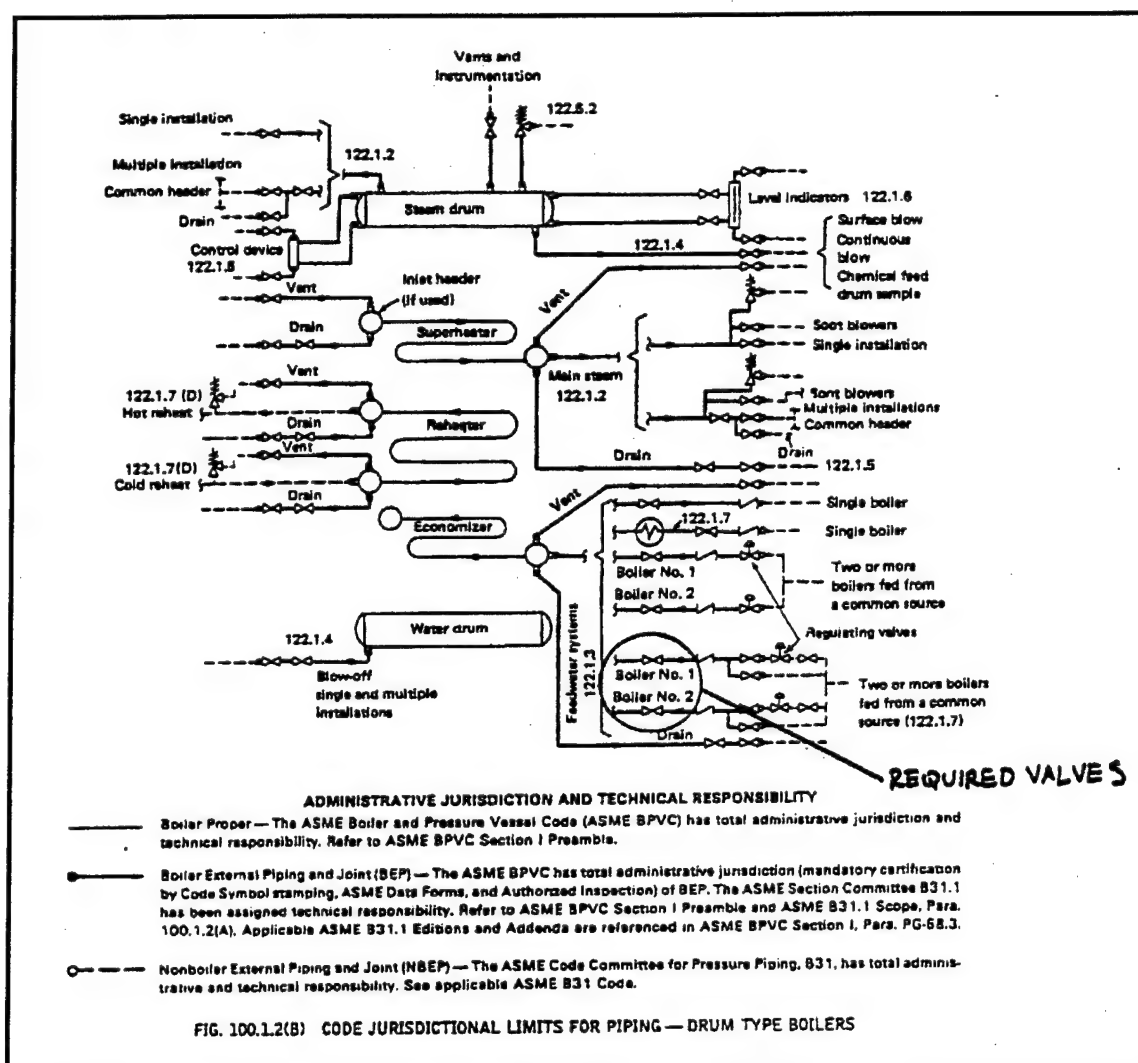
- An ASME Boiler and Pressure Vessel required valve is missing in the feedwater piping. Figure 10 shows ASME Code B31.1, Fig 100.1.2(B). There should be a stop valve isolation valve between the check valve downstream of the feedwater regulation station check valve and the economizer.

Figure 10. ASME Code B31.1, Fig 100.1.2(B).
